Bulletin No.: 01-07-30-032B

Subject: Transmission Oil Leaking From Transmission Vent (Replace Transmission Case Cover Gasket/Channel Plate Gasket)

Models: 1997–2005 Cars and Light Duty Trucks
With Hydra-Matic 4T65-E Automatic Transmission (RPOs MN3, MN7, M15, M76)

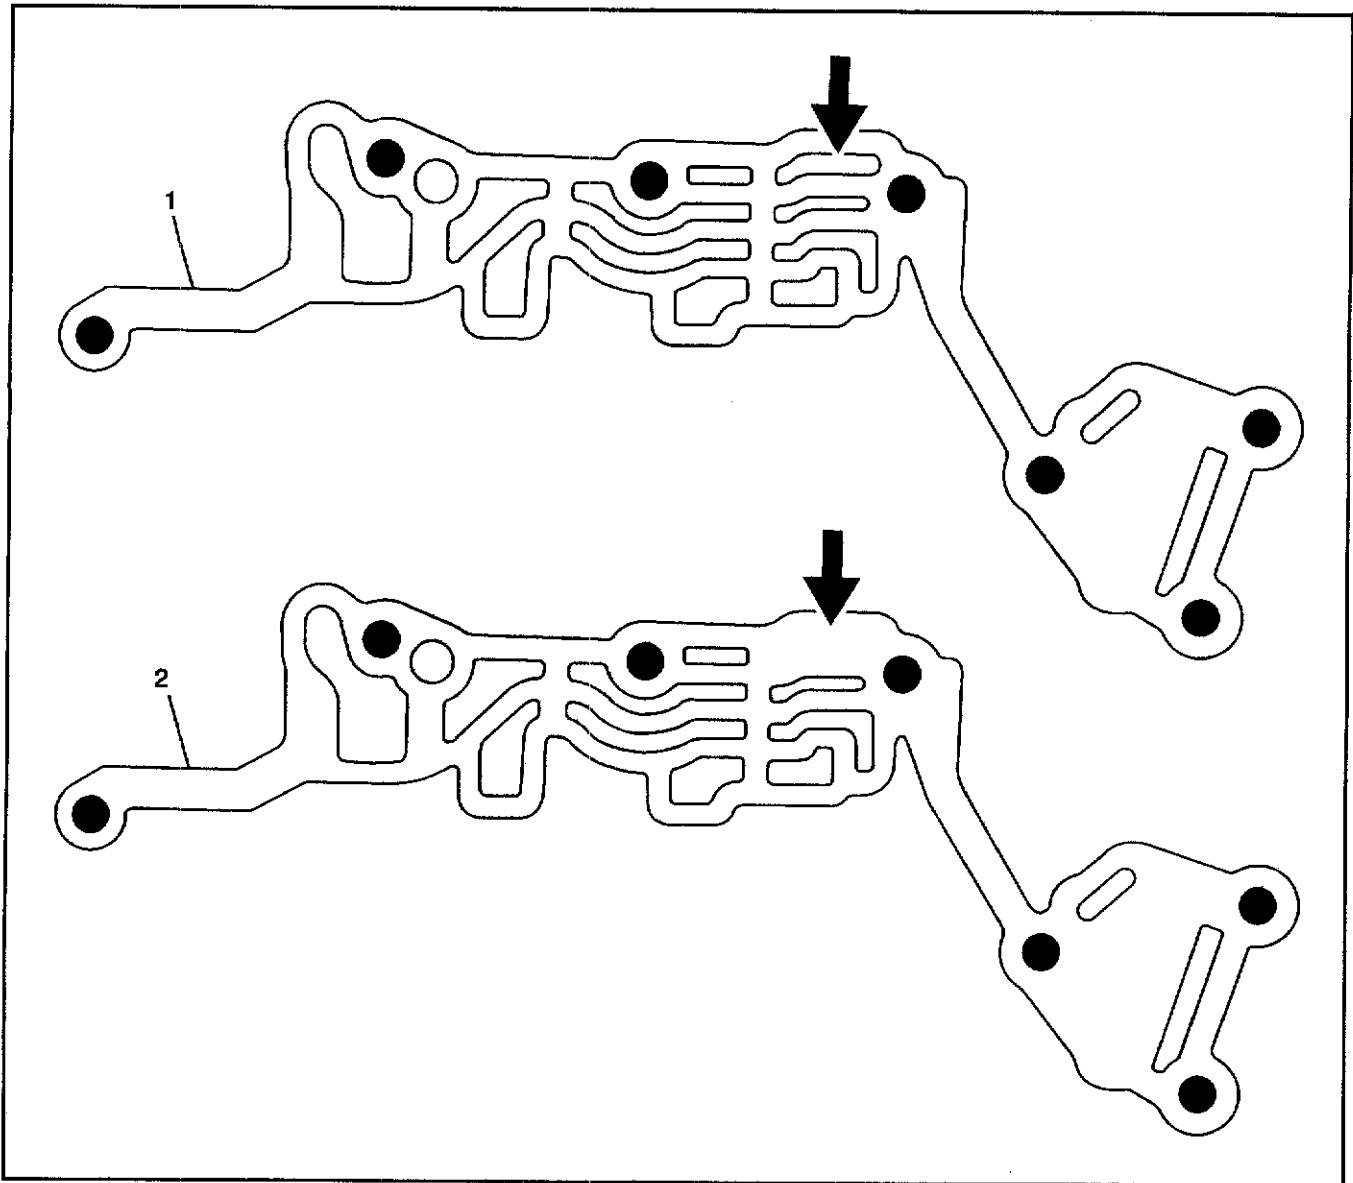
838478

This condition may be caused by an improperly torqued channel plate gasket.

To correct this condition, replace the channel plate gaskets (#429 and #430). Refer to Case Side Cover Replacement in the Automatic Transaxle – 4T65-E subsection of the appropriate Service Manual.
