GM Truck - Fixing A Serious Coolant Leak:

Replacing Intake Manifold Gaskets On A 1999 GMC Jimmy With A 4.3 Liter V6 Engine

This Article May Also Apply To Full-Size GM Pickups, Tahoe, Yukon, and Suburban With 5.7 Liter V8 Engines

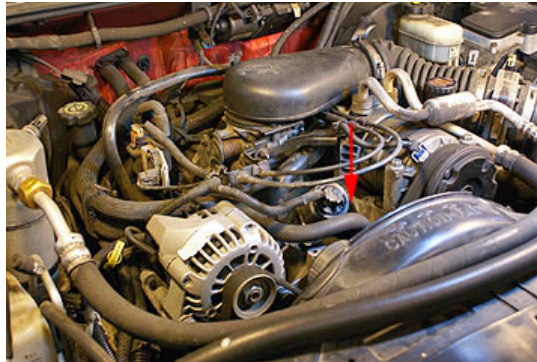
This 1999 GMC Jimmy had developed a serious coolant leak. The engine would lose about a **gallon** of coolant after 20 miles of driving.

I had replaced the water pump less than a year earlier, and initially I thought the pump gasket was leaking. When I leaned over the engine and looked straight down where the red arrow is pointing, I could see coolant dripping from the area near the right-hand mounting surface of the pump.

But an employee at a local auto parts store suggested that possibly the source of the leak was the intake manifold gasket, not the pump.

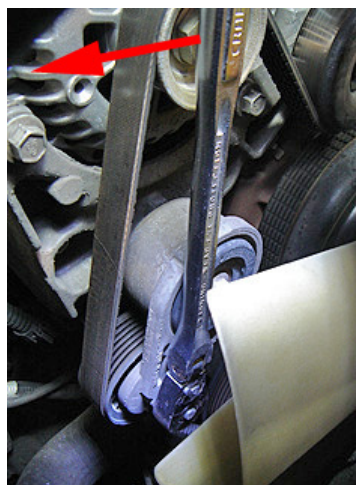
To rotate the tensioner, I inserted a 3/8" drive ratchet into the square hole and pushed the ratchet to the left (arrow). Then I slipped the serpentine belt off the idler pulley.

I found it best to start with the ratchet handle **straight up**, because when the belt is removed the tensioner will **rotate back**, and the wrench handle can hit the water pump pulley, making it impossible to remove the wrench.

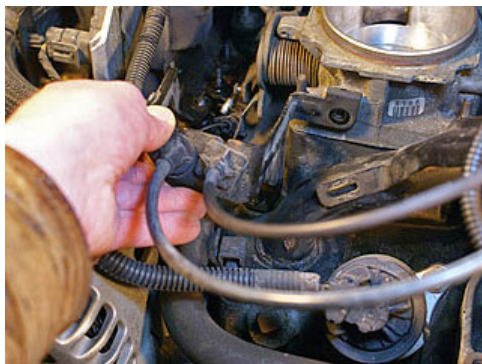
I removed the first throttle cable bracket. I used a 10mm socket to remove the two nuts.

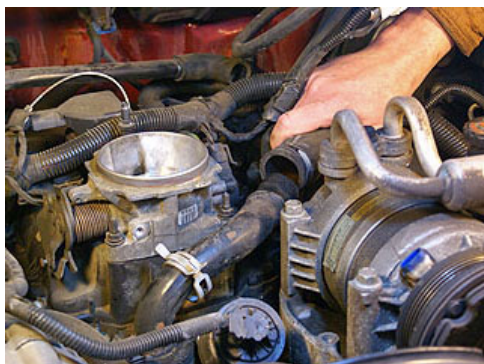
Then I removed the second throttle cable bracket. There were 3 fasteners and they all required a 10mm socket. I moved the throttle cables and brackets far out of the way.

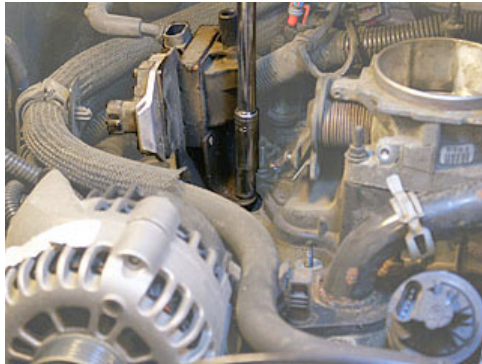
I removed the ignition coil. This required removing two bolts with a 10mm socket.

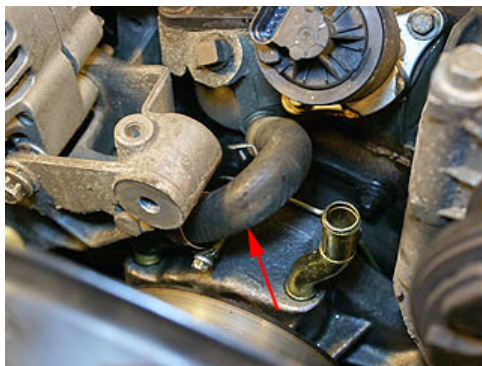
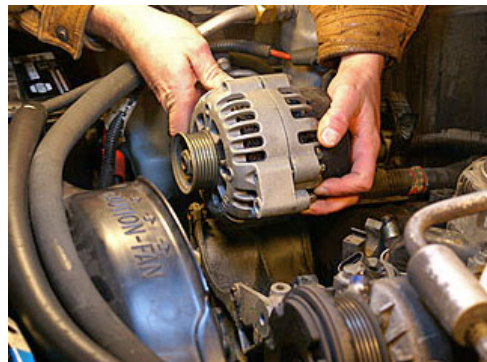
I also needed to remove this "crossover" hose (red arrow) that runs from the water pump to the intake manifold.

But... I did this later, after the alternator had been removed and the bracket moved forward, so I had more room to work.

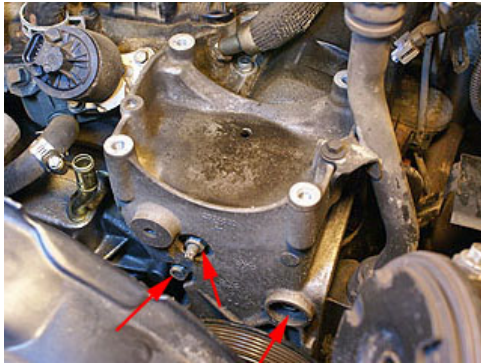
The air conditioning compressor bracket also needs to be unbolted and **moved forward** to get it out of the way. But the power steering pump is attached to this bracket, so the bracket cannot be completely removed without disconnecting hoses.

The arrows indicate the fasteners near the top... 2 bolts and a nut. These required a 14mm socket.

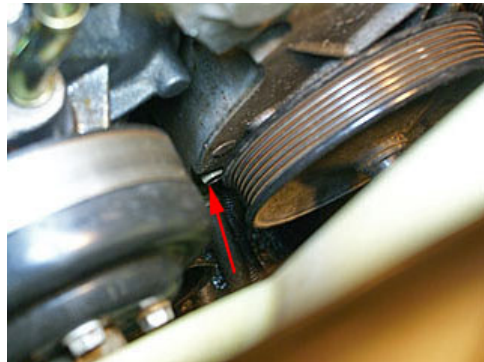
This bolt connects the bottom of the hang hook to the engine. I was able to remove this with a 14mm deep socket and a 2-1/4" extension. I got underneath the car and placed the socket and extension on the nut, then I inserted the ratchet **from above** and loosened the nut.

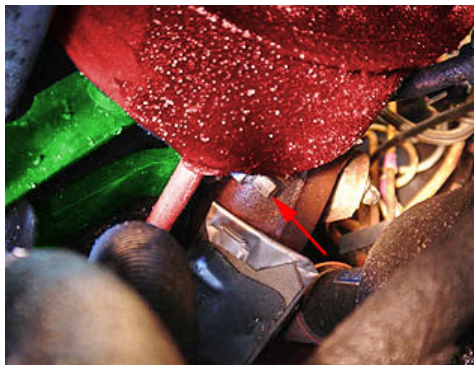
This other fastener (red arrow), which is a **stud with a nut**, also connects the hang hook to the engine, just a few inches higher up.

Removing this nut was a b-i-t-c-h. A 14mm **deep** socket was too long (the ratchet hit the steering column) and I when I put a 14mm **short** socket on my ratchet I couldn't engage the hex on the nut. I was about to go buy a set of "mid-length" sockets, but I tried something else. I placed the short socket on the nut, then I slipped the ratchet into the socket *part way*. I turned the ratchet and the nut came off. Whew!

The good news was... this engine has been leaking so much oil and coolant that both of these nuts had no corrosion, so they came off without a fight.

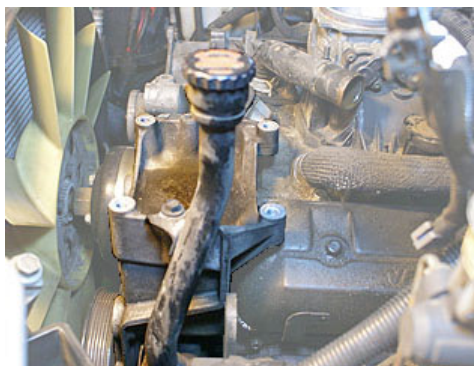
This picture shows the A/C bracket in the normal position...

... and the bracket after being pulled forward about 2-3 inches. The movement is limited by the upper-most power steering hose. By making a slight U-bend in the hose I was able to bring the bracket forward as far as possible without sliding it off that long stud.

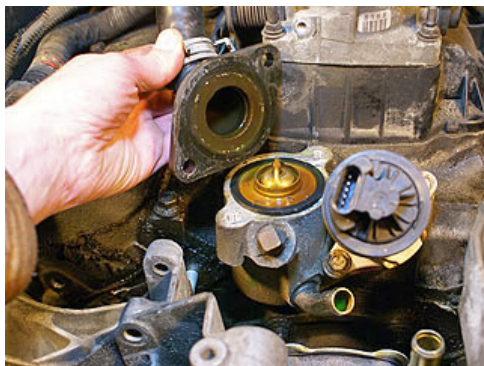
I used a small prybar to break the thermostat housing free from the intake manifold. The thermostat sits in a recess in the manifold. The thermostat has its own rubber gasket, so there is no other gasket required.

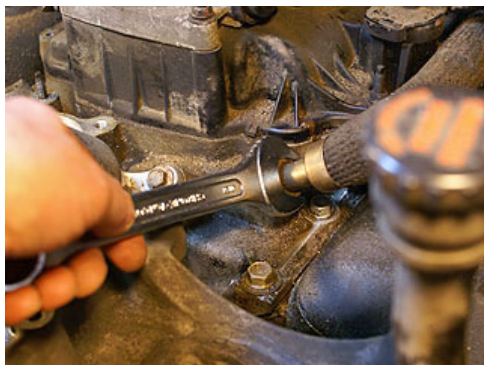
I believe this tube (1) is the EGR (exhaust gas recirculation) tube, and the motor (2) controls the EGR valve which is buried inside the intake manifold.

I was able to loosen the tube fitting with a 22mm open-end wrench. A 7/8" wrench fit kinda sloppy, but it also turned the fitting.

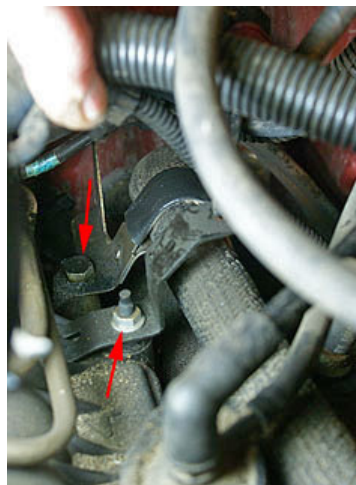
There was also a hold-down bracket on the EGR tube towards the back of the engine, which I removed. The upper arrow indicates the bolt for that bracket.

The lower arrow points to a metal bracket that supports some wires. I also removed this bracket. Note that the bolt **below** this bracket is for the upper intake manifold.

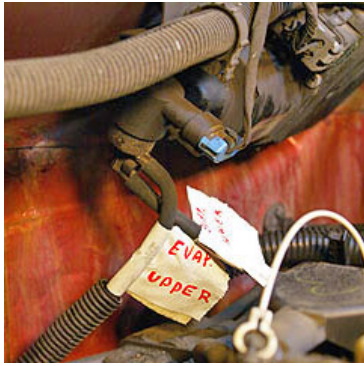
I tagged these small vacuum hoses (I think they are part of the evaporative emissions system) so I could remove them and get them out of my way. This may not be necessary.

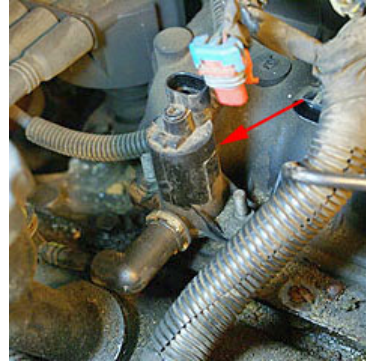
I'm guessing that this device is the evaporative emissions purge solenoid that is mentioned in the Chilton's book.

I removed the pair of screws and moved it out of my way.

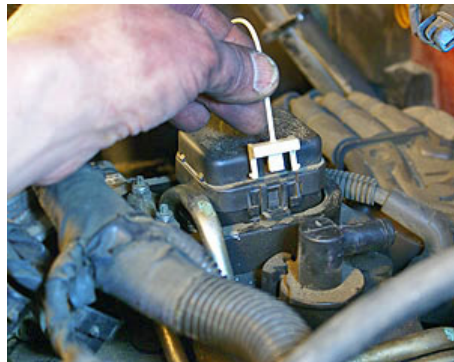
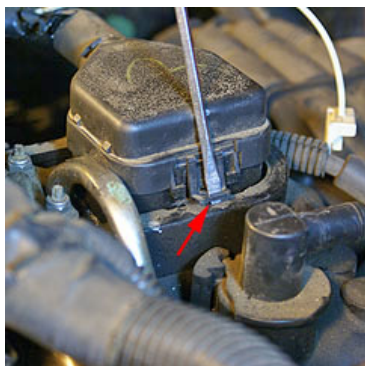
First I pulled this white release "pin" upwards to remove it.

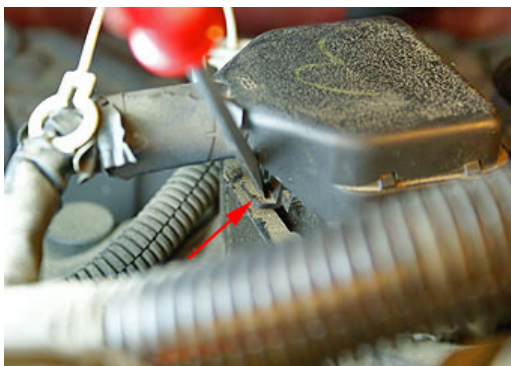
Then I used a small flat screwdriver to pull this "U"-shaped tab outwards.

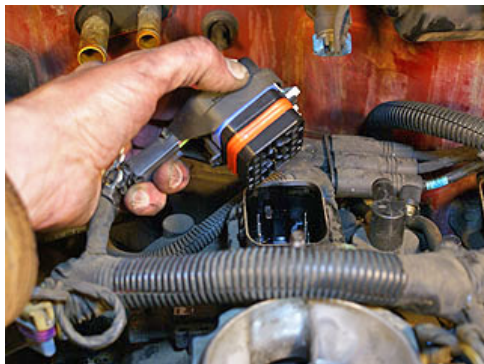
There was another U-shaped tab on the other side of the connector, under the incoming wires. I pulled this outward with a screwdriver.

It was kinda tricky to keep these tabs from re-engaging. I pulled the connector upward after releasing the tab, so it wouldn't re-engage.

I grabbed the connector body and pulled upwards and it came out.

Notice how clean it is inside this connector. That's good.

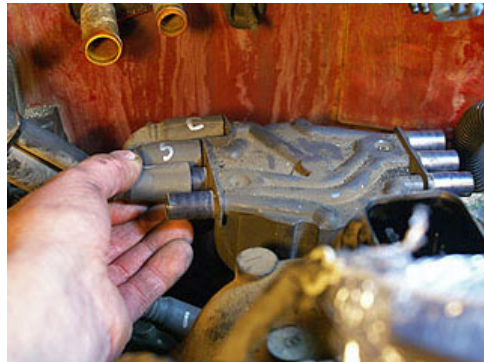
So I removed the spark plug wires. Note that my numbering was wrong, but that doesn't matter as long as the wires go back in the same locations.

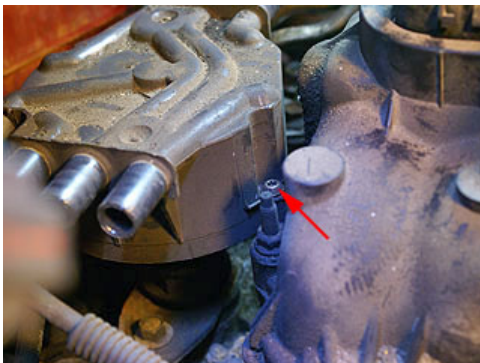
The distributor cap is secured with two small **Torx**-drive screws. These required a **T20** bit. Each screw is located at the bottom of a notch in the cap.

I used a T20 bit on a 1/4" extension to remove these screws.

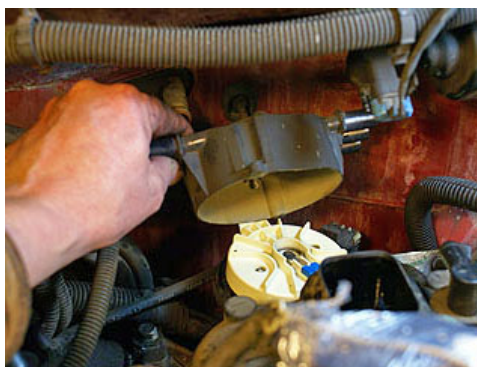
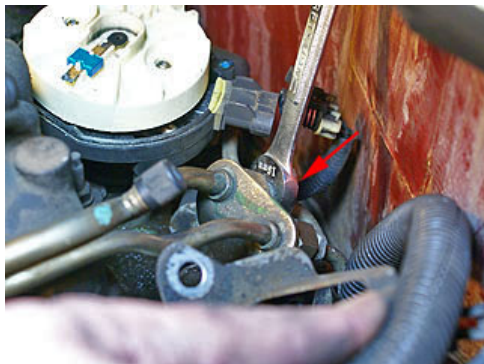
I used a 16mm open-end wrench on the fuel line connectors. I also held the larger nut with a 19mm open-end wrench, but I didn't show it in the picture because then you couldn't see a darn thing.

There was very little room to maneuver at the back of the engine, and I did not expect this to be easy. But, the fittings came loose without much effort.

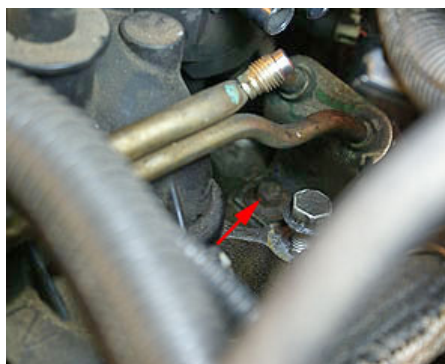
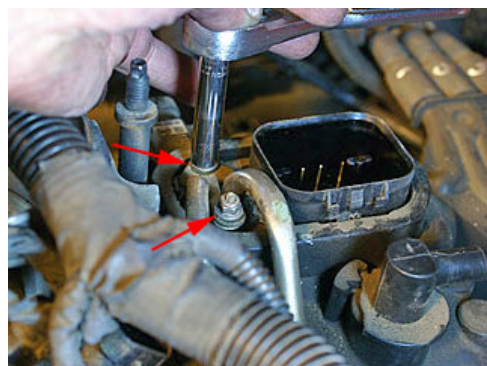
Next I removed this bolt (arrow) that held the fuel lines at the back of the engine.

This required a 10mm socket.

Using an 8mm socket, I removed two nuts (red arrows) where the fuel lines enter the fuel injection unit.

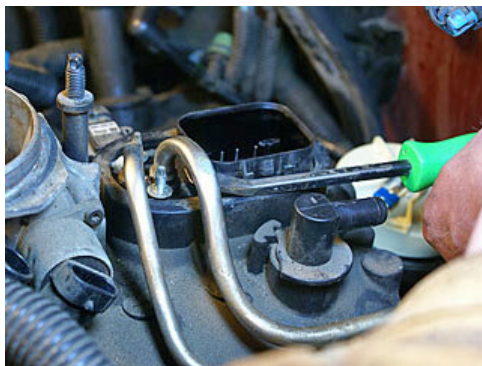
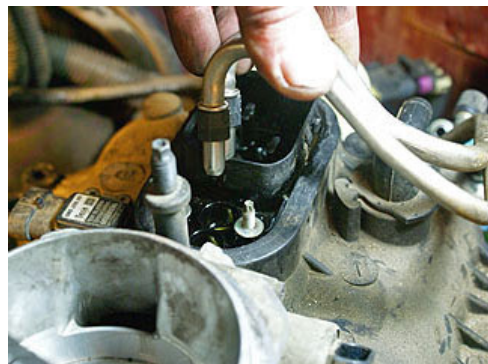
I lifted the fuel lines out.

But... before doing this, I **cleaned the area** around these tubes with a spray can of automotive brake parts cleaner and some Q-tips. There was a lot of dirt around this area, and if any of that grit gets into the fuel system it can ruin one or more fuel injectors.

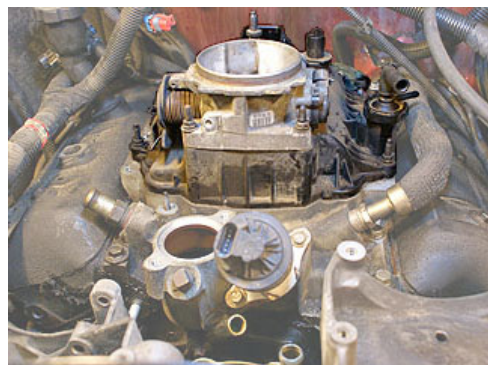
At this point the upper intake manifold and throttle body were ready to be removed.

I used a bungee cord to lift that big wiring harness out of the way.

I used a 10mm deep socket to remove the bolts along the side of the upper intake manifold.

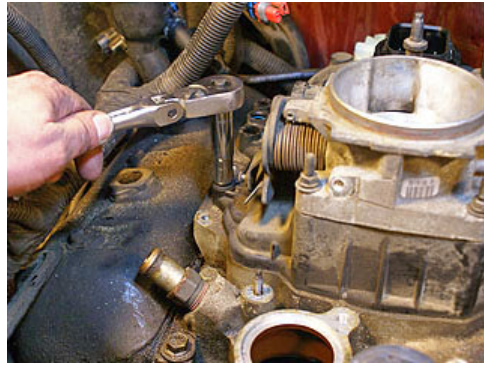
There were two long bolts at the front of the throttle body, and two regular bolts at the rear of the upper intake manifold.

Once all the bolts were removed, the manifold was loose but it wouldn't lift up.

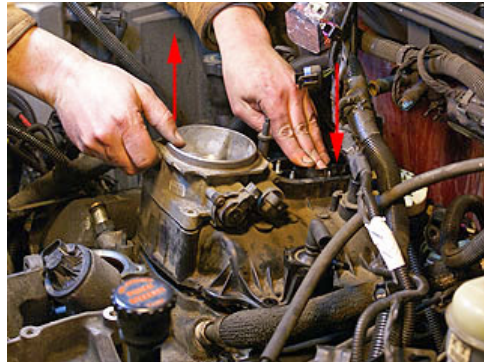
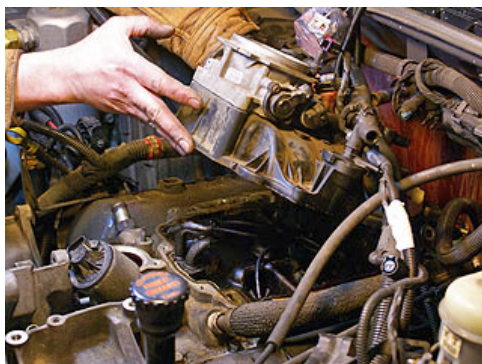
I pressed down on the fuel injection part while I lifted the front of the throttle body.

Then the upper intake manifold was completely free.

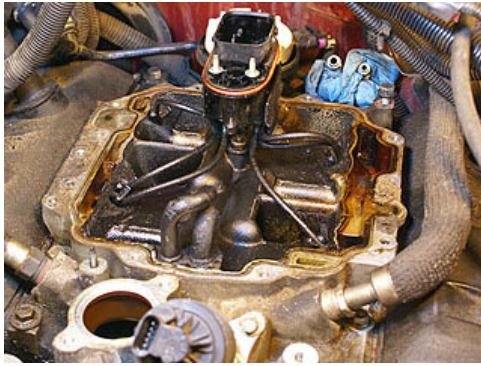
The view from the front. I was surprised at how dirty this was. I believe the black stuff is oily residue that is drawn

into the engine from the crankcase. I'm not sure if this stuff does any harm.

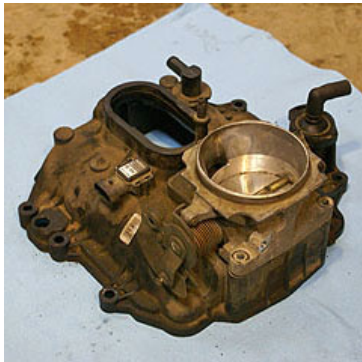
The bottom of the upper intake manifold, which is also called the *plenum*.

The orange line is a rubber gasket that sits in a deep groove in the manifold.

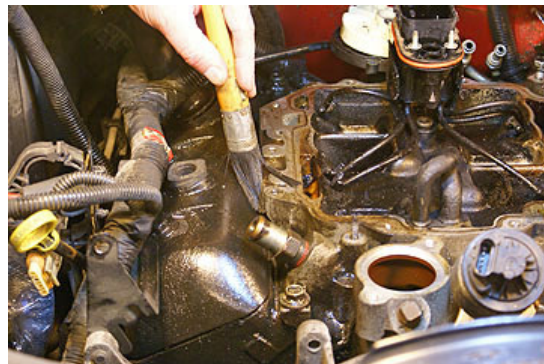
I used mineral spirits and a brush to clean the areas between the intake manifold and the cylinder heads. There was a lot of dirt and grit on the engine, and I didn't want this to get inside the engine when I removed the manifold.

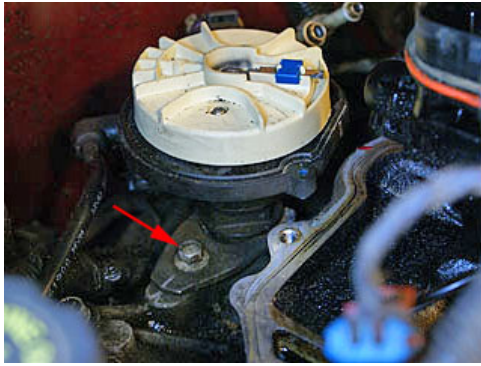
The distributor is held down with one bolt (red arrow).

However, reaching this bolt with a wrench can be very difficult. Some mechanics use a special tool called a "distributor wrench" which is basically an L-shaped wrench that can reach under the distributor. But I didn't have one.

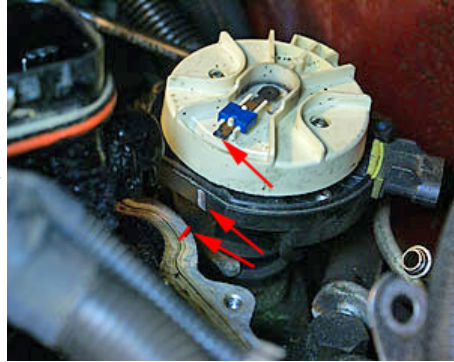
I made match marks on the distributor body (middle arrow) and on the intake manifold (lower arrow) to indicate the original rotor position when the distributor is replaced. (The upper arrow indicates the tip of the rotor.)

To make the mark on the distributor body, I used a silver-colored Sharpie marker. Other good marking methods are paint markers or White-Out correction fluid.

To make the match-mark on the lower intake manifold, I used a **red marker AND a scratch-awl**. It's important to make a decent scribe mark in the metal, because after the manifold is cleaned up with an abrasive disc the mark will be hard to see.

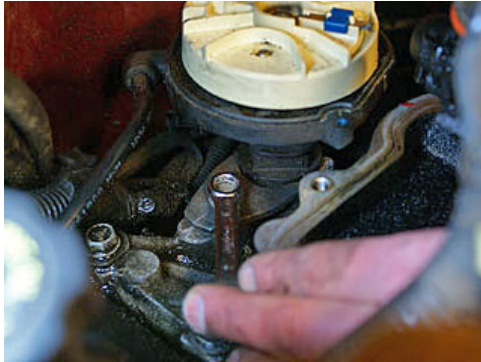
Using a **short** 10mm wrench, I was able to loosen the distributor hold-down bolt.

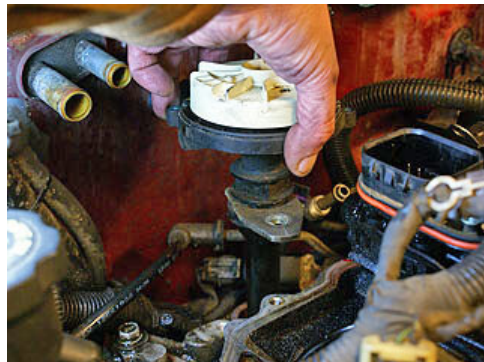
The distributor after being removed.

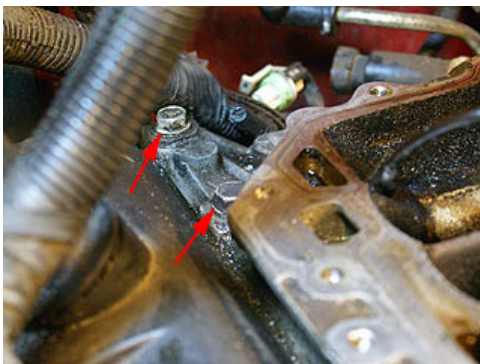
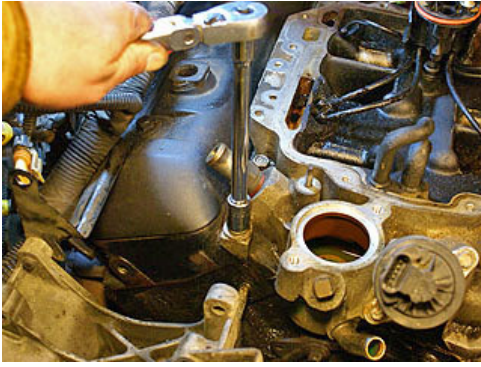
I removed the bolts with a 13mm socket, long extension and ratchet. First I **loosened each bolt** and then I removed them all.

I used a pry bar to loosen the intake manifold, by prying under the front of the manifold just above the timing chain housing.

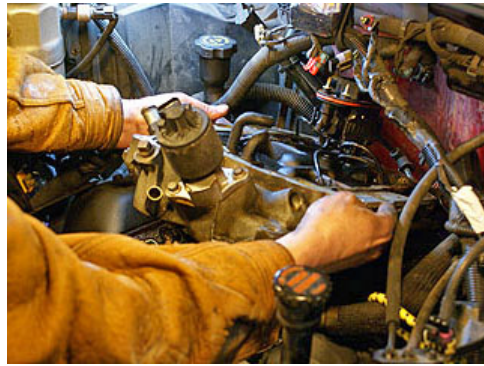
This is the engine with the lower intake manifold removed.

The red arrow points to a **plastic cover** (a Saran Bowl Cover, actually) that I placed over the open ends of the fuel lines. I needed to keep dirt out of the fuel lines because even the smallest piece of dirt could plug a fuel injector.

There were several **small puddles of antifreeze** in here, which must have been spilled as I lifted the manifold off. I used a paper towel to soak up any puddles of coolant, which can create problems when it mixes with engine oil. (Remember... this area is bathed with engine oil.) I'll change the oil after I'm done with this repair, just in case anything gets into the crankcase.

I found this bad spot in the intake manifold gasket at the **front right**. If I pushed on this spot it would move around... as though there was nothing behind it. This is adjacent to a coolant passageway. The coolant leak pictured at the beginning of this article was directly above this spot. I found the "smoking gun".

Directly across the "valley", there was another weak spot in the gasket over the front left cooling passage. When I touched the gasket, the hard plastic backing crumbled, creating a weak spot similar to the one in this picture. The left side was ready to start leaking too.

I've read online that Dex-Cool has been accused of degrading the nylon middle layer in the intake manifold gaskets. When I removed the gaskets they broke around every cooling passageway.

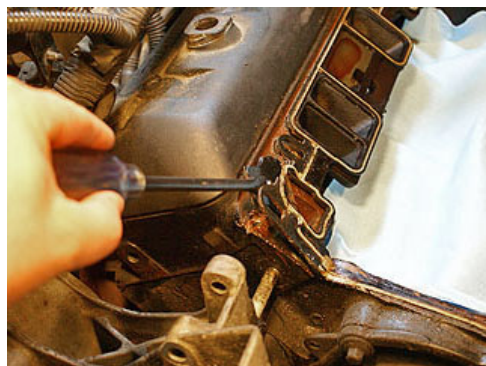
I spent a few minutes with a shop vac and a small screwdriver to scrape off any dirt and suck it into the vacuum cleaner. I want to avoid getting too much grit in the crankcase.

I removed the gasket with a razor-type gasket scraper.

I also placed two **paper towels over the open area** of the engine, to keep loose debris from falling into the engine and blocking an oil passageway or gumming up the camshaft.

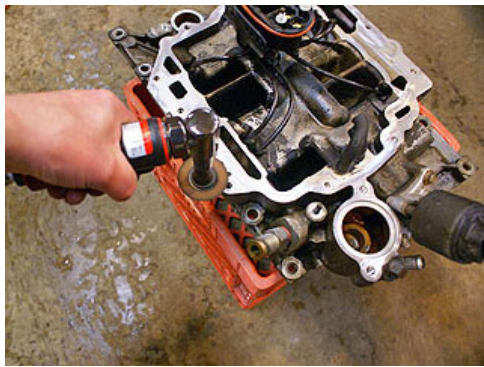
I set the intake manifold on a milk crate and used a die grinder with a Roloc disc to clean up the mating surfaces. First I did the top side.

I turned the intake manifold over and cleaned the mating surfaces on the underside. These are the critical surfaces that mate with the cylinder heads.

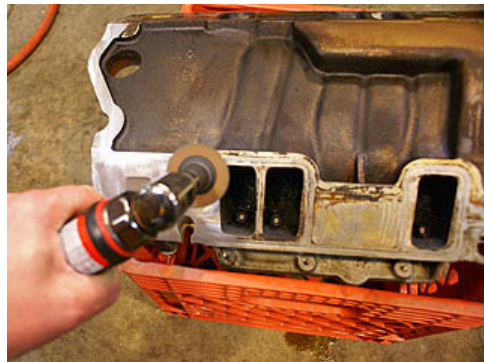
A close up view: These are the fuel injector nozzles. Be

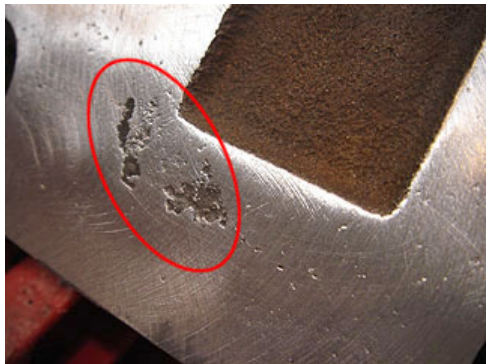
After cleaning the surfaces, I noticed some pitting around the cooling passages where the gasket meets the metal.

I smeared a **thin** layer of RTV silicone (which came with the new intake gaskets) over the pitted areas around the cooling passageways.
I did this on the cylinder heads (shown here) and also on the intake manifold.

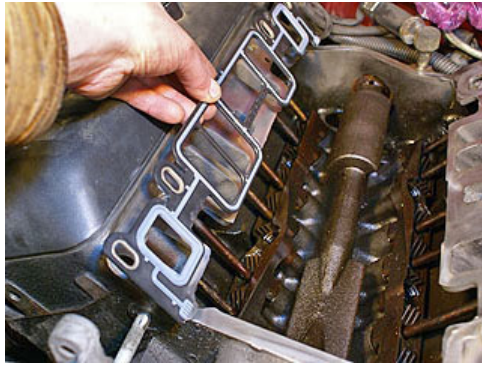
There are a pair of small tabs on the back of the manifold gaskets. These tabs go into a pair of holes in the cylinder head, so the gaskets don't slide around during assembly.

I applied a bead of RTV silicone sealant to the front and back flat sections of the engine block.

I made sure to apply the sealant a bit thicker at the ends where the flat meets the cylinder head.

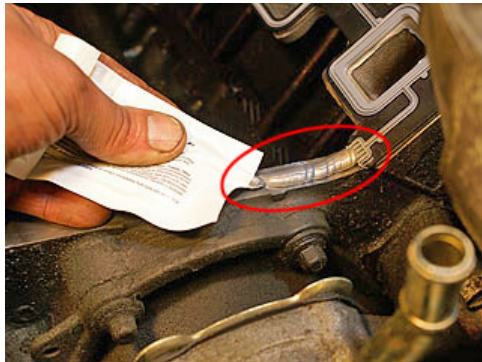
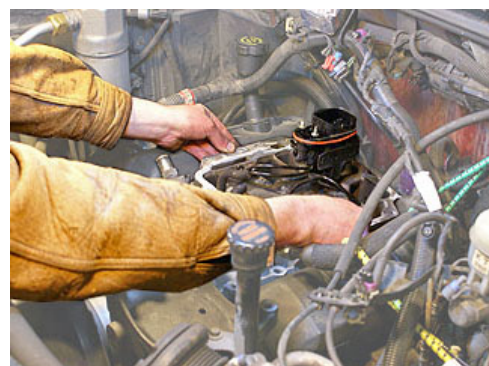
I set the intake manifold in place, making sure it wasn't too far forward or rearward.

I installed the bolts and tightened them with a 13mm socket and a 6" long extension.

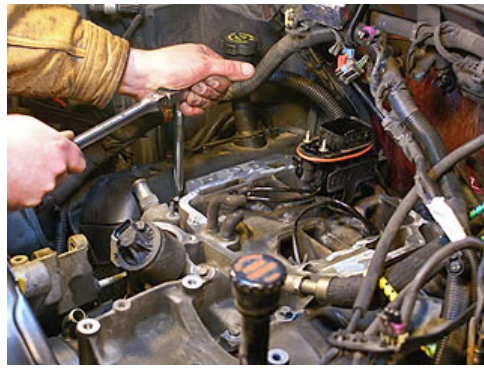
Intake Manifold Bolt Tightening Sequence 1996 to 2000 4.3 V6 Engine:

I marked up this photo of the manifold to show the bolt tightening sequence.

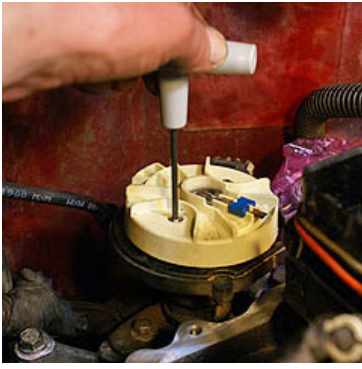
Compare the old and new rotors.

An old, worn out and corroded rotor can cause a weak spark, which can result in poor fuel economy. Maybe we'll get better mileage after this.

Notice the corrosion on the tip of the metal on the old rotor. This is typical. I believe this is the first time the rotor has been replaced in 9 years and 160,000 miles.

It's sometimes possible to clean up the rotor tip with emery cloth, but this rotor was badly corroded and worn.

I spent 13 bucks and replaced the rotor.

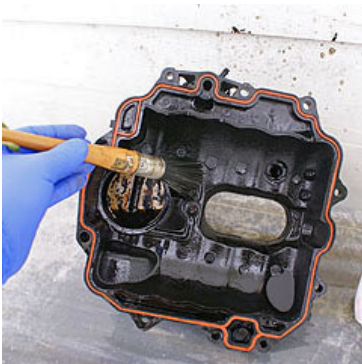
I cleaned up the upper intake manifold with mineral spirits and a brush. I also used carburetor cleaner to clean the deposits from around the throttle plate.

Note that the gasket is still in place. I removed it before the final cleaning. Then I carefully wiped the gasket groove clean.

I discovered that the throttle body can be easily removed from the upper intake manifold. I removed the post with a 7/32" socket and a 1/4" drive ratchet.

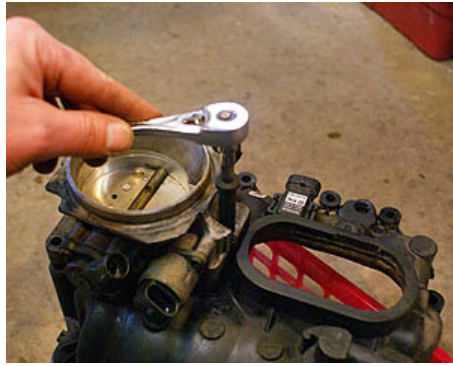
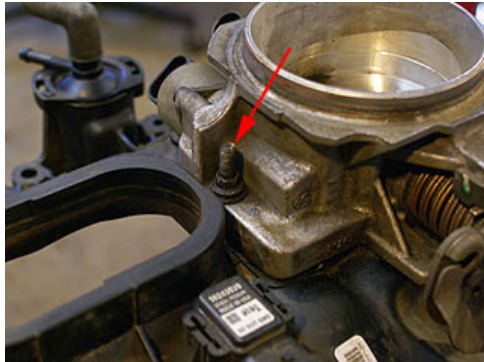
After the post was removed, there was a nut below it.

Directly below the nut was a large hex head. I held this with a 15mm box-end wrench and removed the nut above, which required an 8mm deep socket.

DO NOT try turning the 15mm hex head screw. It's molded into the plastic.

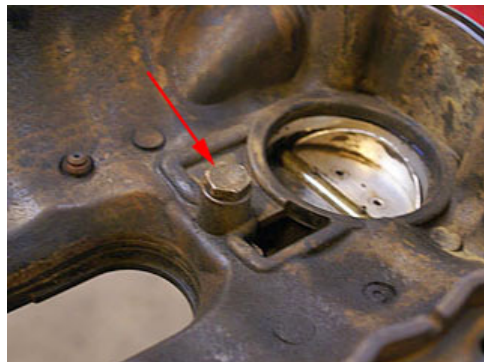
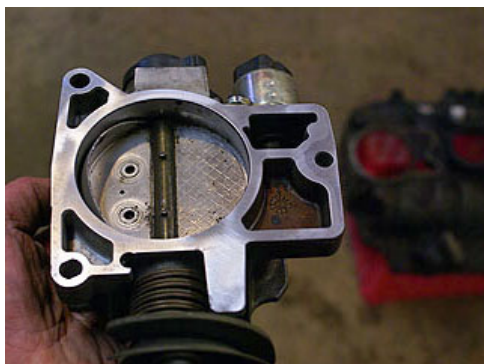
After removing the throttle body, I cleaned the bottom surface with a Roloc disc on a die grinder.

Then I removed the throttle body gasket with a hook tool.

I cleaned out the gasket groove and installed the new gasket.

Then I installed that **post** that secures the rear of the throttle body. I put some blue thread locker on the bolt threads, about a third of the way from the end.

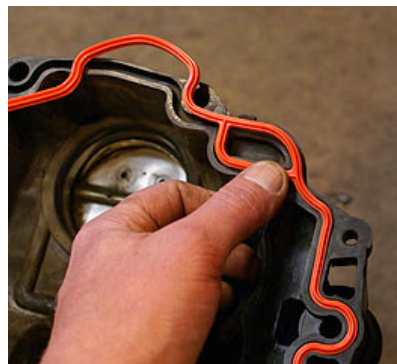
I installed the new gasket on the bottom of the upper intake manifold.

I also replaced this o-ring around the central fuel injection area.

(The upper intake manifold gasket set came with a replacement for this o-ring and the throttle body gasket.)
