Document ID# 671781
2001 GMC Truck Jimmy - 4WD

Gear Tooth Contact Pattern Inspection

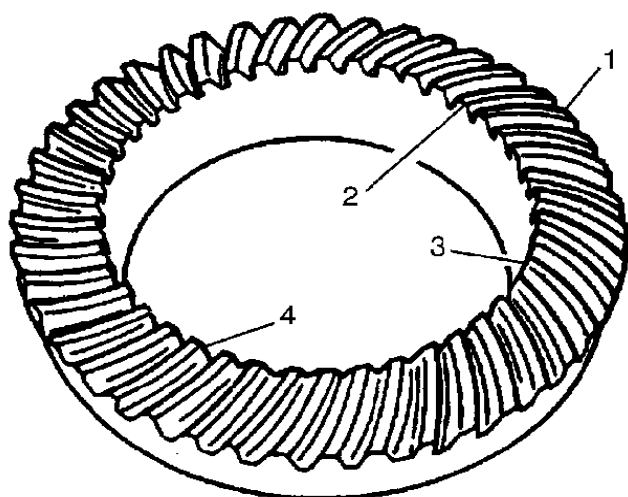
[Gear Tooth Nomenclature](#)

The side of the ring gear tooth which curves outward, or is convex, is the drive side (4). The concave side is the coast side (3). The end of the tooth nearest the center of the ring gear is the toe end (2). The end of the tooth farthest away from the center is the heel end (1).

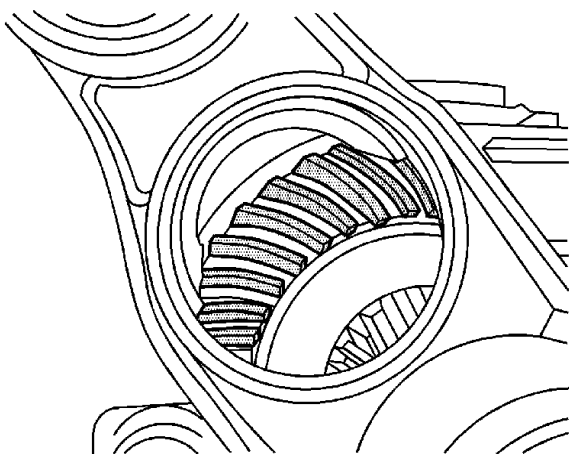
2. Use a medium stiff brush in order to sparingly apply gear marking compound GM P/N 1052351 (Canadian P/N 10953497) or equivalent to all of the ring gear teeth.

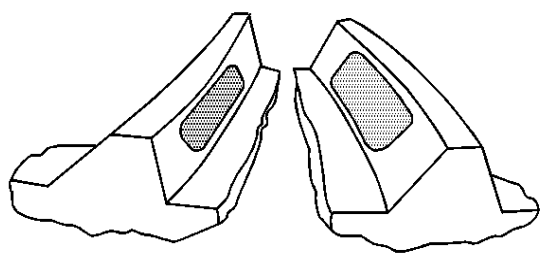
Correct Contact Pattern

The backlash and pinion depth is correct.

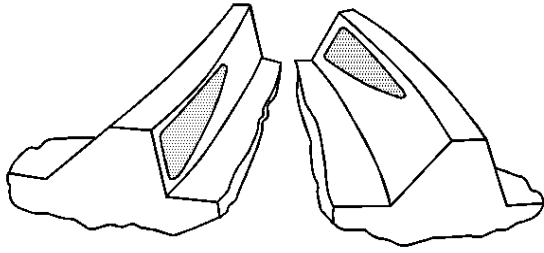
[Drive Side Heel -- Coast Side Toe Contact Pattern](#)

The pinion depth is incorrect. The drive pinion is too far away from the ring gear.

Adjust the pinion depth of drive pinion. Refer to [Pinion Depth Adjustment](#) .

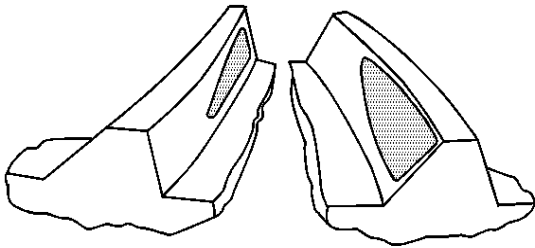
[Drive Side Toe -- Coast Side Heel Contact Pattern](#)

The pinion depth is incorrect. The drive pinion is too close to the ring gear.

Adjust the pinion depth of drive pinion. Refer to [Pinion Depth Adjustment](#) .

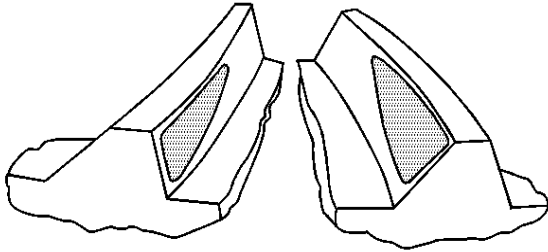
[Drive Side Heel -- Coast Side Heel Contact Pattern](#)

The backlash is incorrect. The ring gear is too far away from the drive pinion.

Decrease the backlash. Move the ring gear closer to the drive pinion by adjusting the side bearing adjuster sleeves. Refer to [Backlash Inspection and Adjustment](#) .

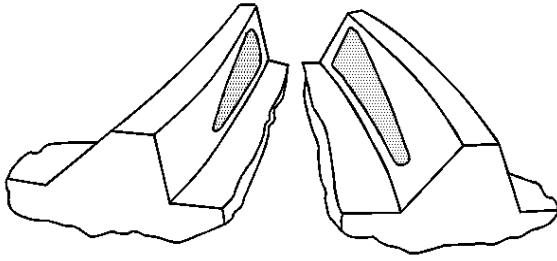
[Drive Side Toe -- Coast Side Toe Contact Pattern](#)

The backlash is incorrect. The ring gear is too close to the drive pinion.
