Document ID# 603161
2000 Chevrolet/Geo Blazer - 4WD

Ignition Switch Replacement - On Vehicle

Removal Procedure

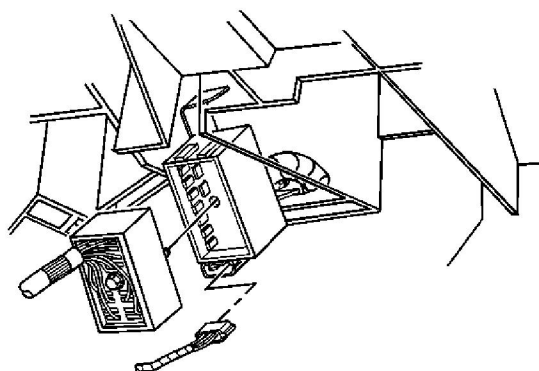
1. Disable the SIR system. Refer to [Disabling the SIR System](#) in SIR.
2. Remove the steering column trim covers from the steering column. Refer to [Steering Column Trim Cover Replacement - On Vehicle](#) .

3. Disconnect the steering column electrical connectors.

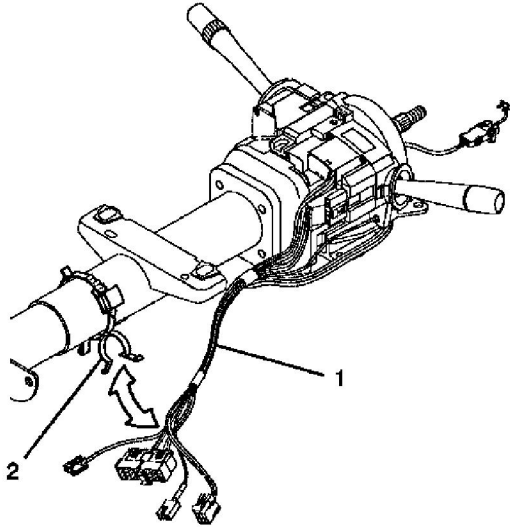
4. Remove the wire harness assembly (1) from the wire harness straps (2) and the steering column.

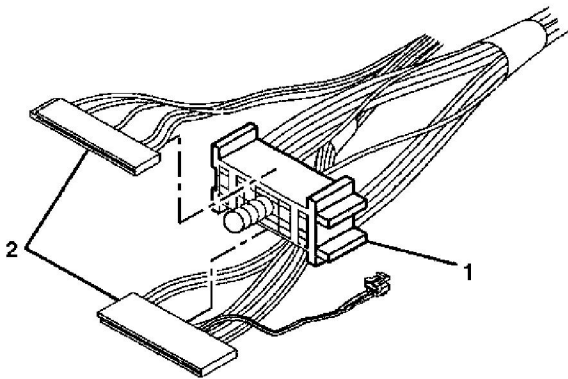
5. Slide the 2 connectors (2) of the turn signal and multifunction switch assembly out of the bulkhead connector (1).

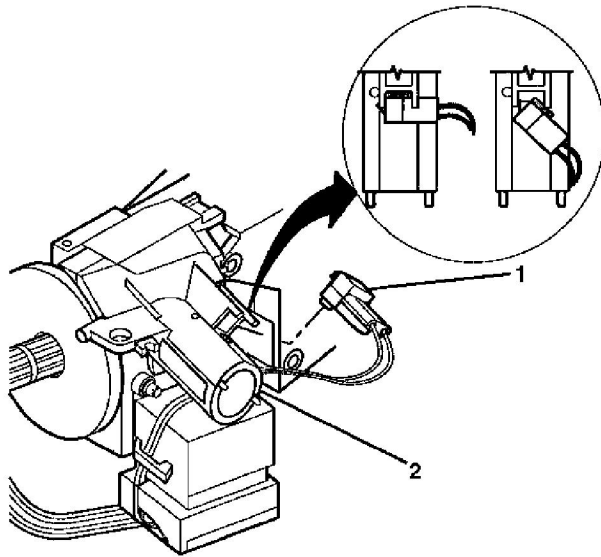
6. Remove the key alarm connector (1) from the lock module assembly (2) in the following way:
 - A. Rotate the key alarm connector (1) 90 degrees.
 - B. Pull the key alarm connector (1) out of the lock module assembly (2).
 - C. Remove the passkey connector from the lock module assembly (2).

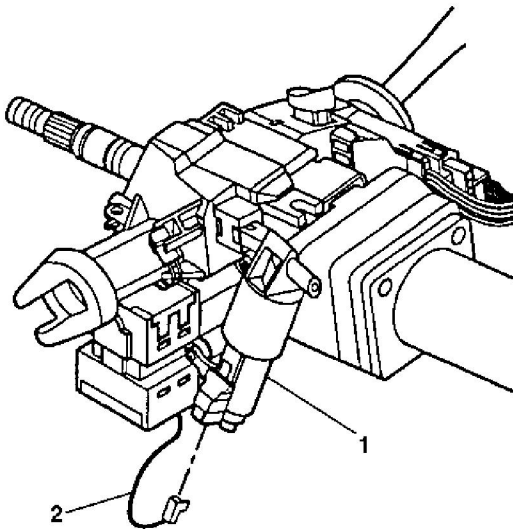
7. Remove the connector (2) from the electric park lock (1), for vehicle equipped with floor shifters.
