Document ID# 553965
2000 Chevrolet/Geo Blazer - 4WD

DTC P0108 Manifold Absolute Pressure (MAP) Sensor Circuit High Voltage

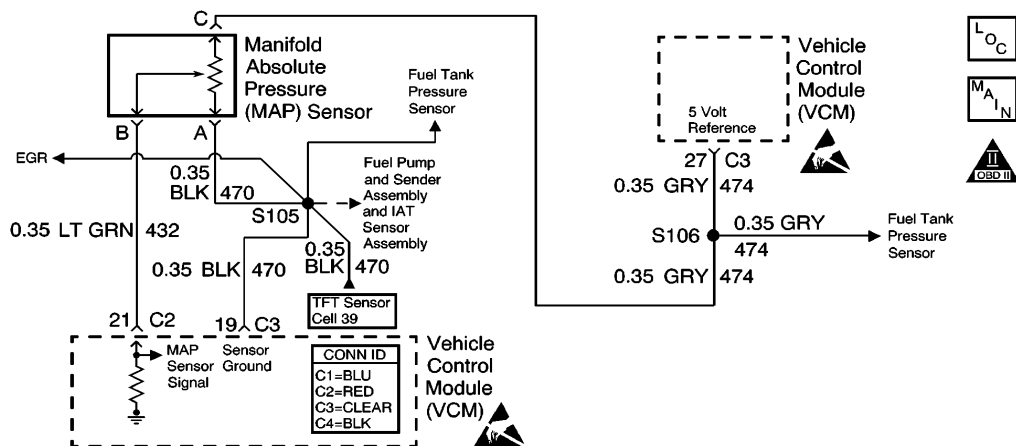
The manifold absolute pressure (MAP) sensor is a pressure sensor. The control module supplies the MAP sensor a reference voltage, signal, and ground circuits. When manifold vacuum is low, the MAP sensor signal voltage rises to a value near the reference voltage, and the MAP sensor signal voltage decreases when the manifold vacuum increases. The control module monitors the MAP sensor signal circuit voltage in order to calculate the vacuum within the intake manifold.
